Manhole Inspection Summary

Manhole # S09II1006MH

Insp Date: **1/12/09 3:15 PM**

Location Address: **3001 RIDGEWOOD AVE**

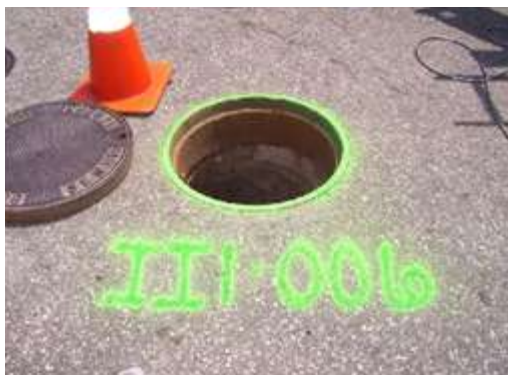
Location View

OFFSET CHANNEL AND DEBRIS ON BENCH

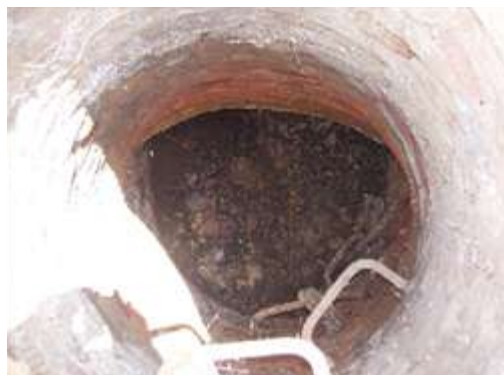
Top View

OFFSET CHANNEL AND DEBRIS ON BENCH

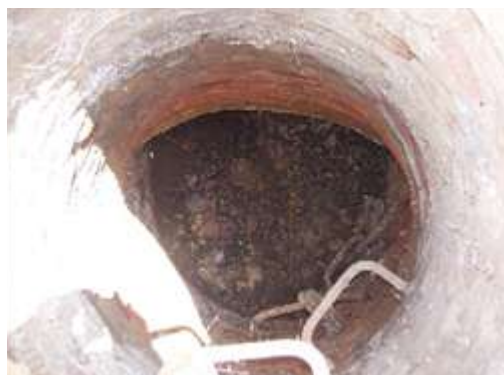
Defect 1

Condition: ☐ Sound ☐ Cracked ☐ Root Intrusion ☐ Loose Brick ☒ **Deteriorated**

DETERIORATED CORBEL

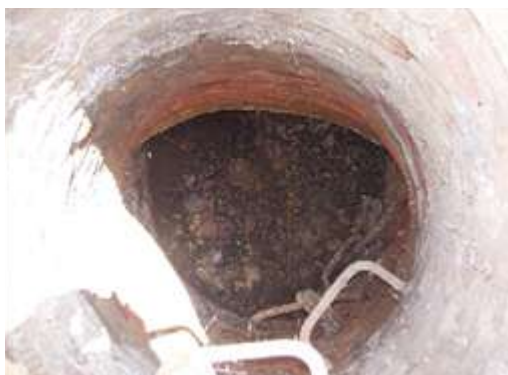
Defect 2

OFFSET CONDITION

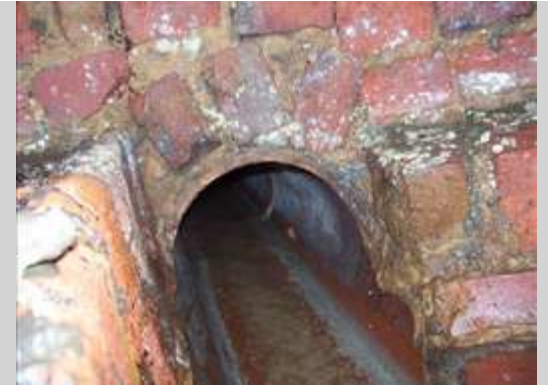
12 O'Clock Outflow

8 in. Circular Gravity Sewer
Pipe Out @ 12 O'Clock

Pipe Height: (in.) Direct
Pipe Material: **Clay** ☐ Pipe Lined
Invert Depth: **9.04** (ft.) Flow Characteristics: **Slow**
Deposits: ☒ None ☐ Mud ☐ Sludge ☐ Debris ☐ Grease
Silt Depth: (in.) Deposits Extent:
Infiltration: **None** Pipe Seal Cond: **Sound**

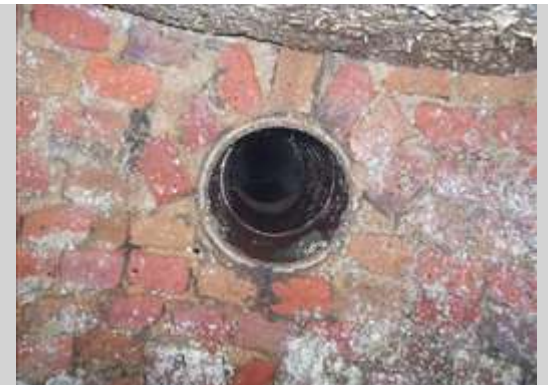
3 O'Clock Inflow

8 in. Circular Gravity Sewer
Pipe In @ 3 O'Clock

Drop In @ 3 O'Clock

Pipe Height: (in.) Direct
Pipe Material: **Clay** ☐ Pipe Lined
Invert Depth: **7.48** (ft.) Flow Characteristics: **None**
Deposits: ☒ None ☐ Mud ☐ Sludge ☐ Debris ☐ Grease
Silt Depth: (in.) Deposits Extent:
Infiltration: **None** Pipe Seal Cond: **Sound**

Drop: **Outside Direct**
Angled: Reading: (ft.)
Inv Depth: **8.98** (ft.)

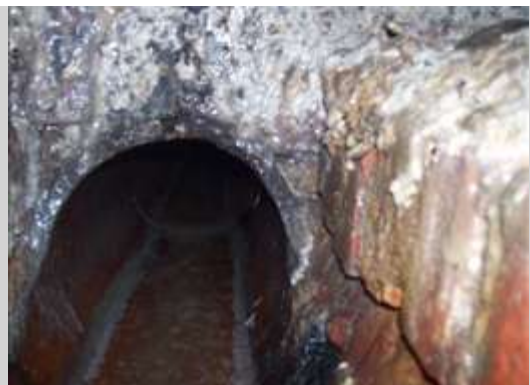
6 O'Clock Inflow

8 in. Circular Gravity Sewer
Pipe In @ 6 O'Clock

Invert Depth: **9.02** (ft.) Flow Characteristics: **Slow**

Infiltration: **None** Pipe Seal Cond: **Sound**
